Zortman Mine Reclamation Progress

- **Reclamation Includes:**
 - Backfilling
 - Regrading
 - Barrier Installation
 - Soil Placement
 - Revegetation
 - Maintenance
- **Some Reclamation done by ZMI prior to 1998**
- **Interim Reclamation began in 1999 by DEQ and BLM after site abandonment by ZMI**

OK/Ruby Pit Reclamation

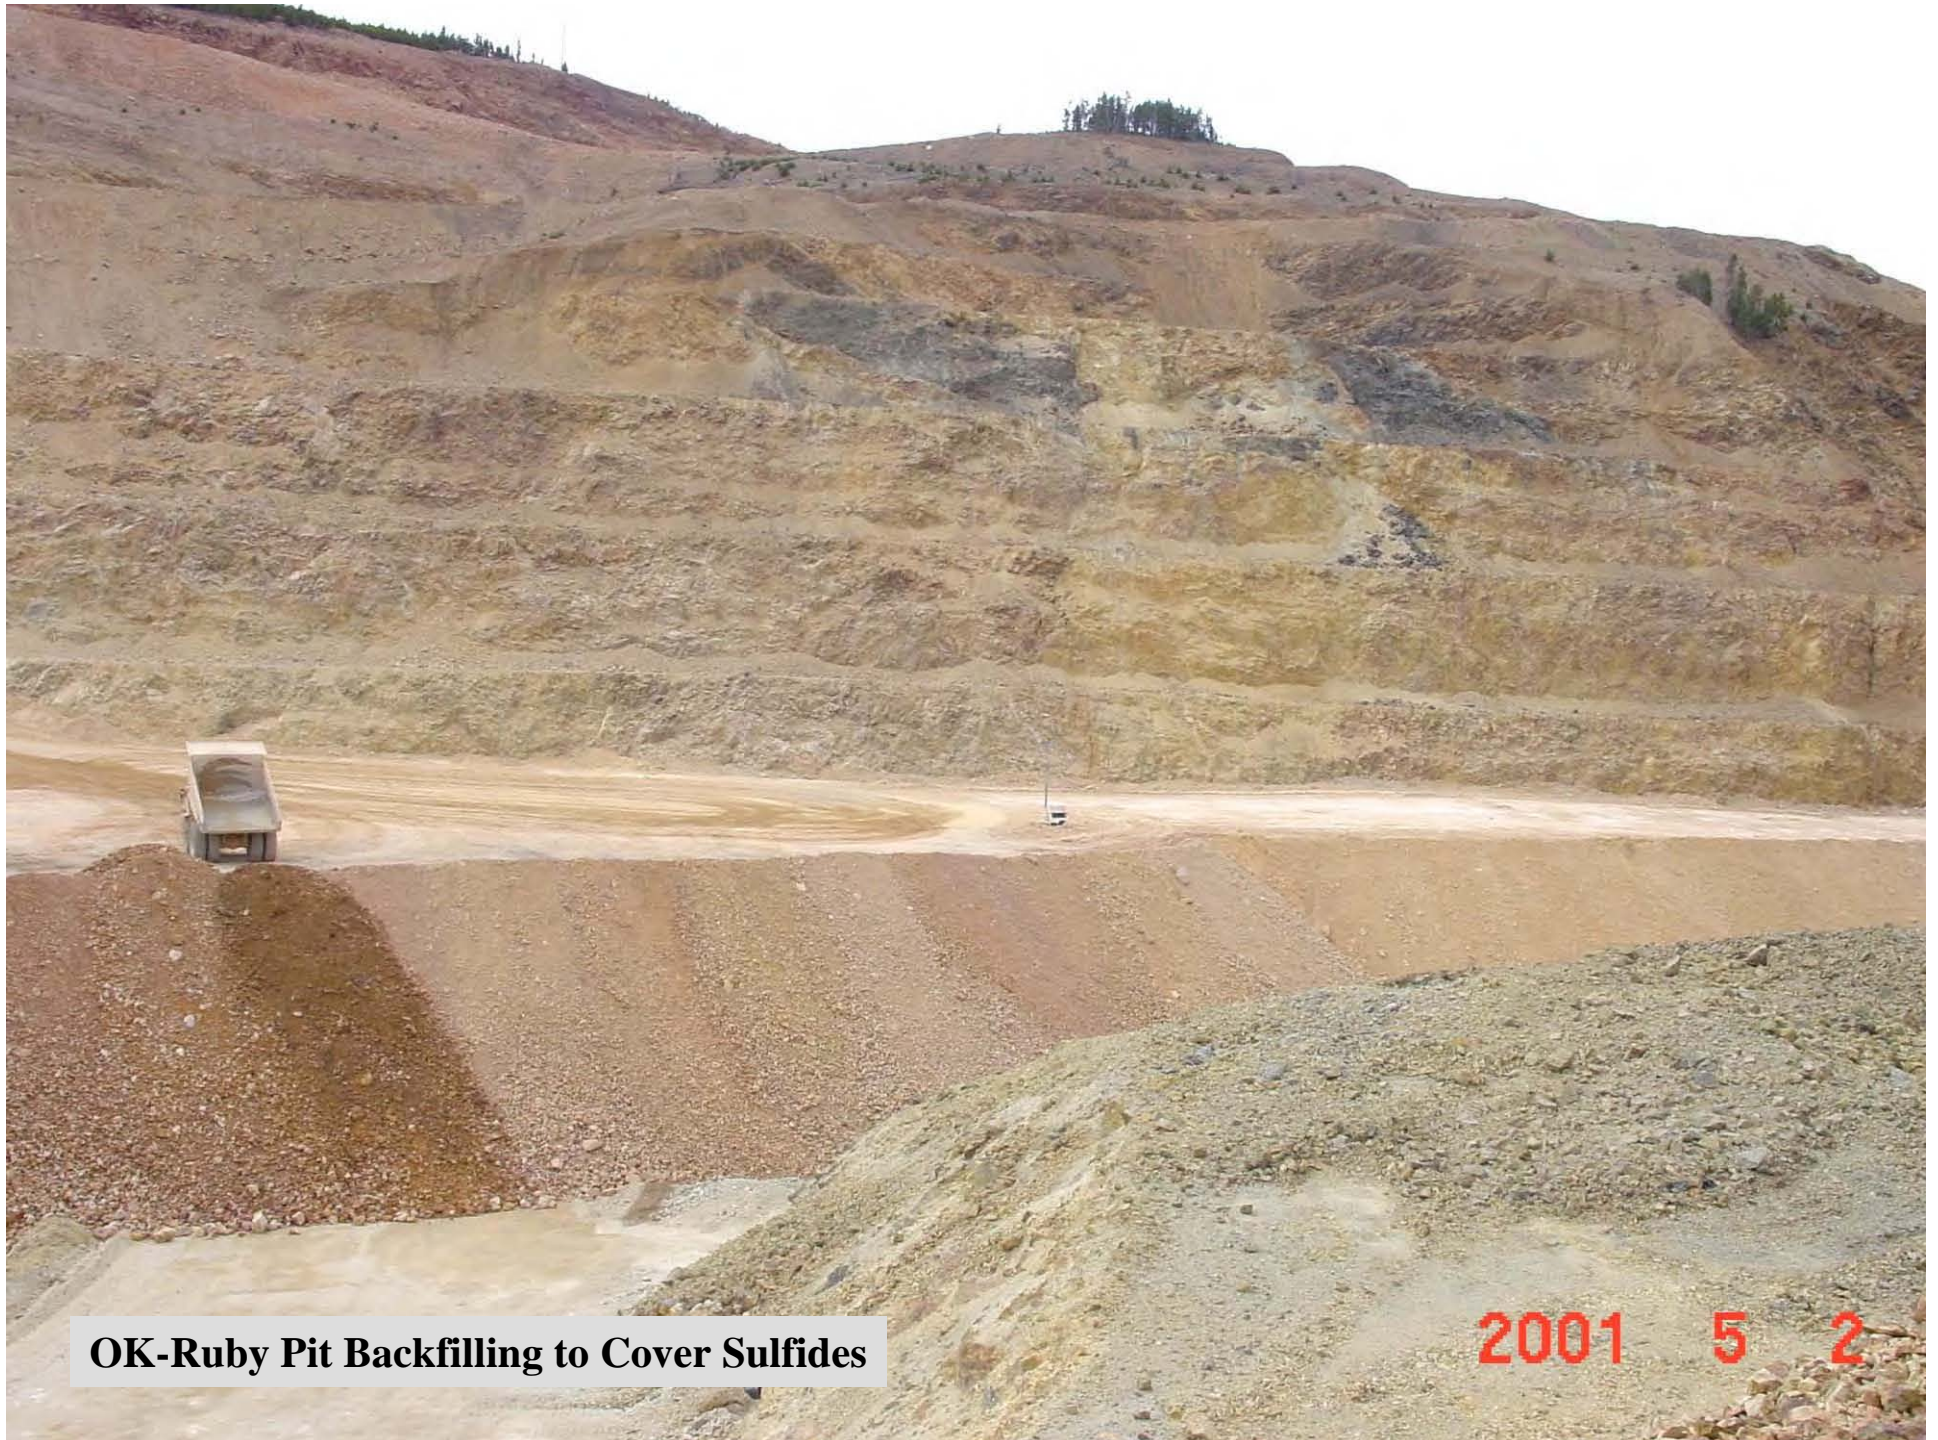
2001 5 2

OK-Ruby Pit Backfilling to Cover Sulfides

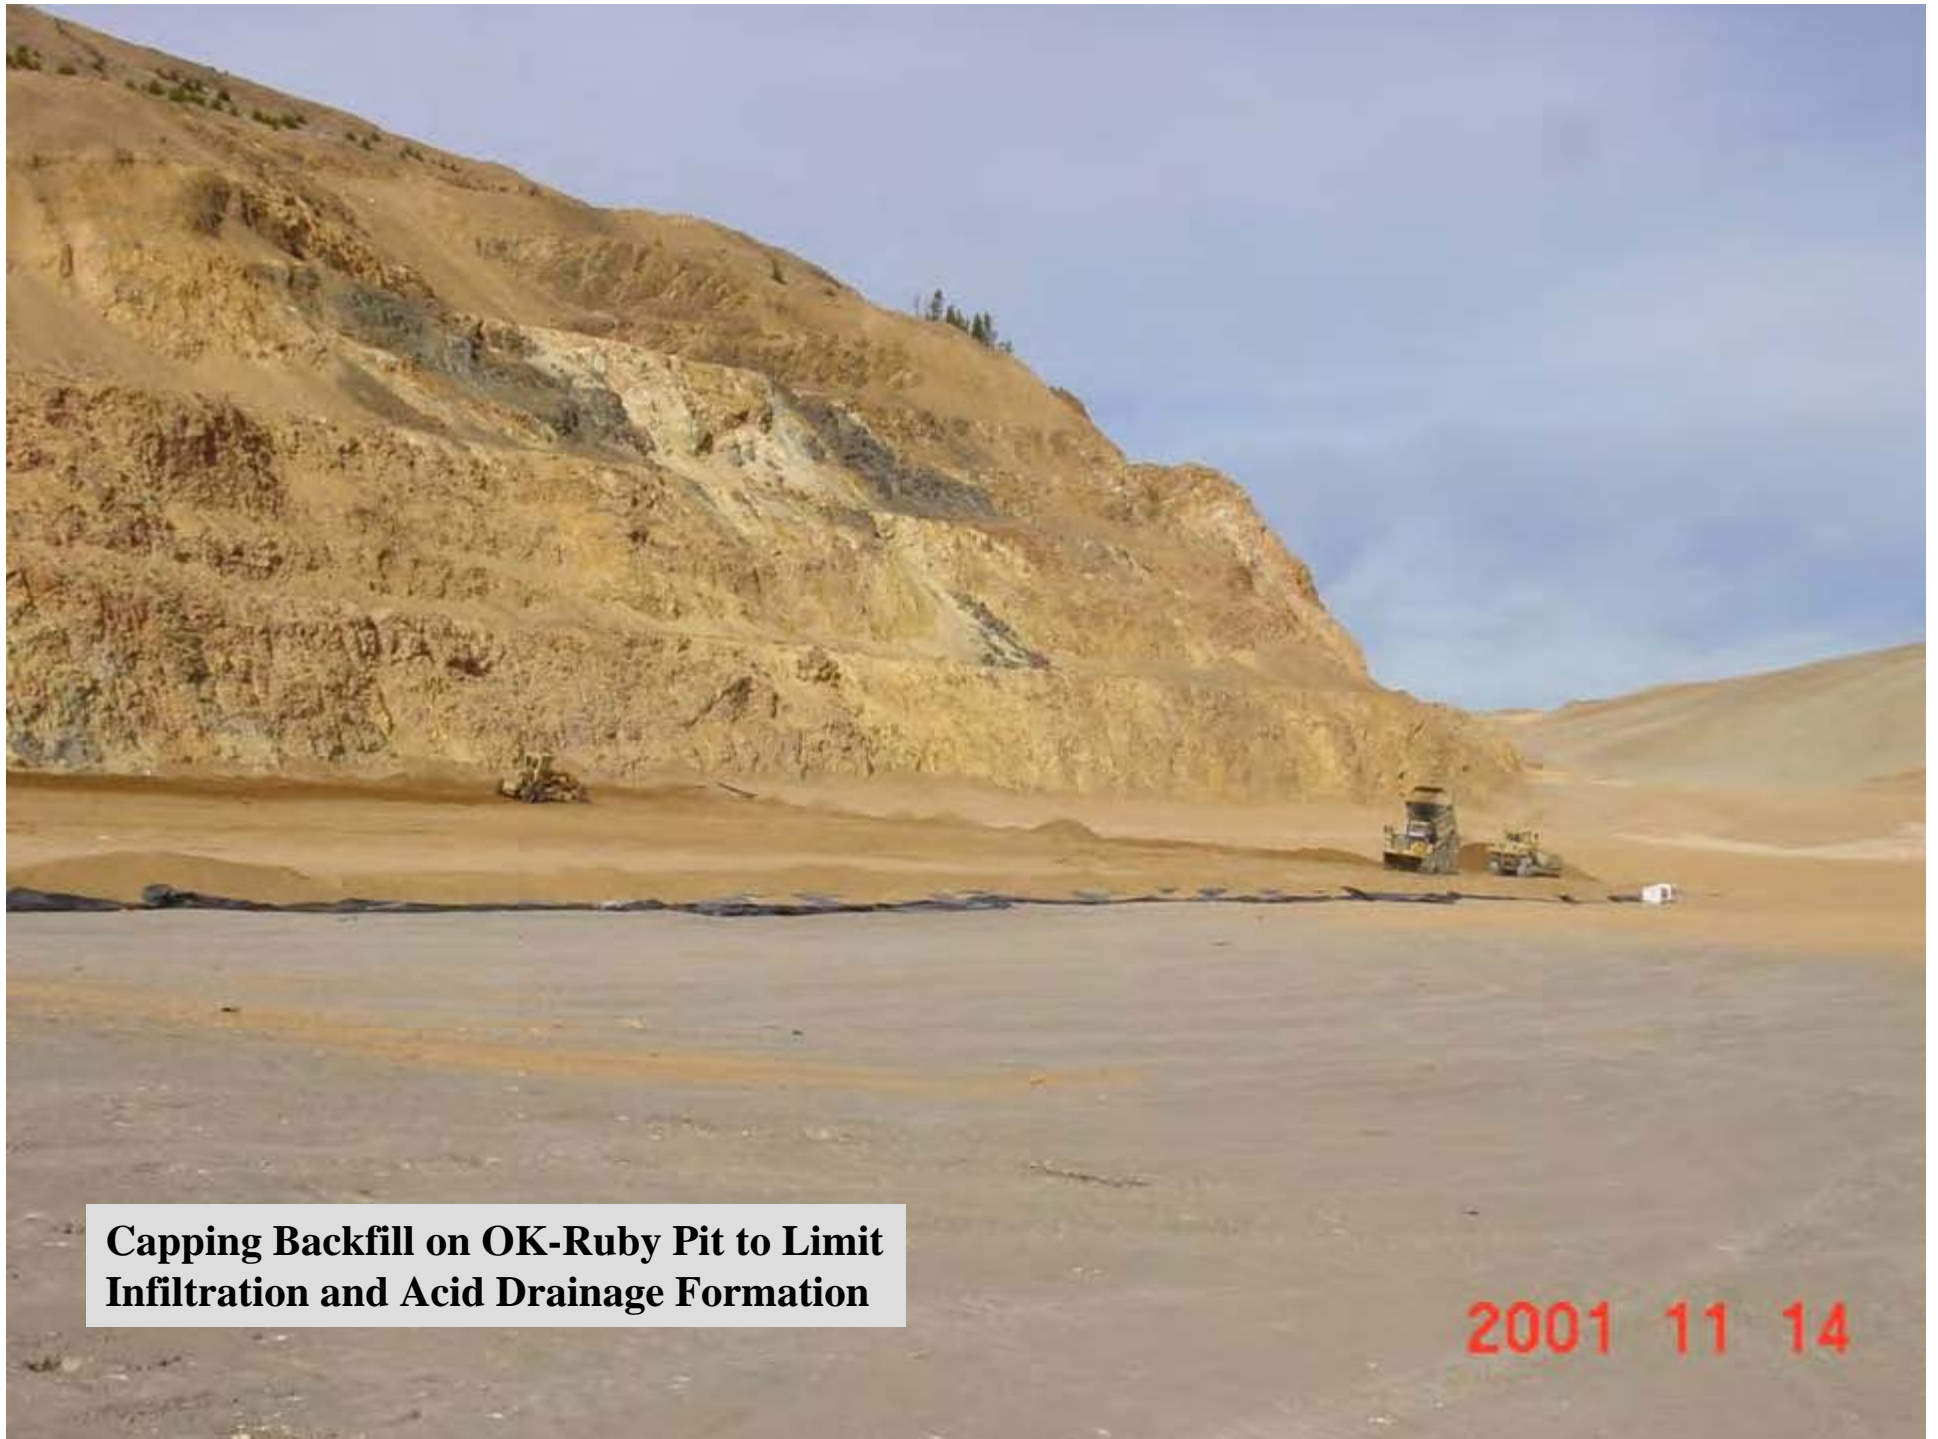
2001 11 14

**Capping Backfill on OK-Ruby Pit to Limit
Infiltration and Acid Drainage Formation**

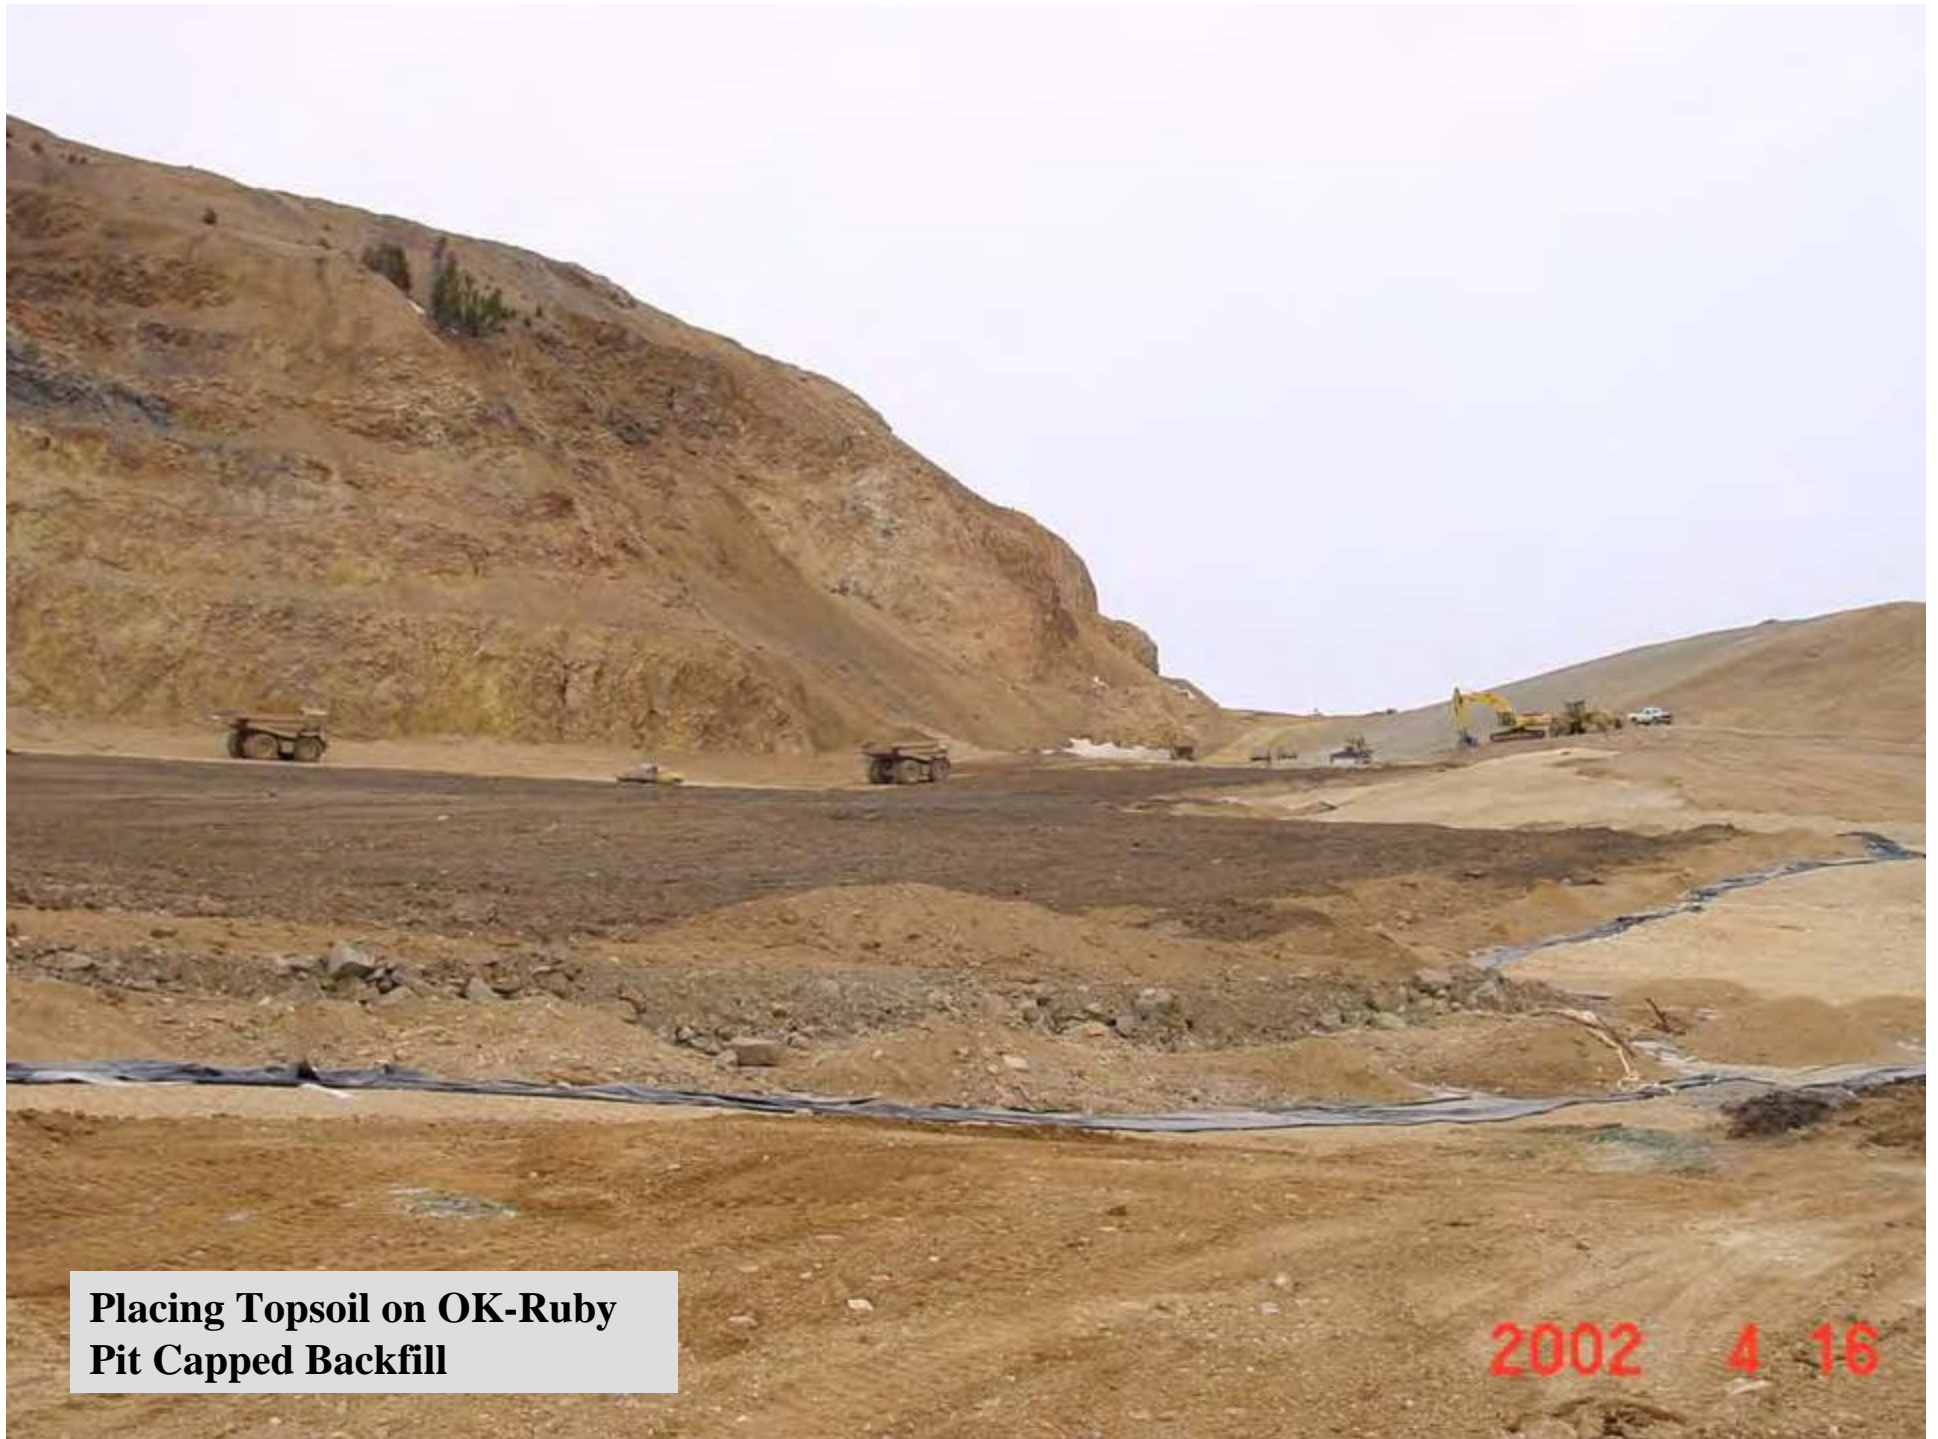
2002 4 16

**Placing Topsoil on OK-Ruby
Pit Capped Backfill**

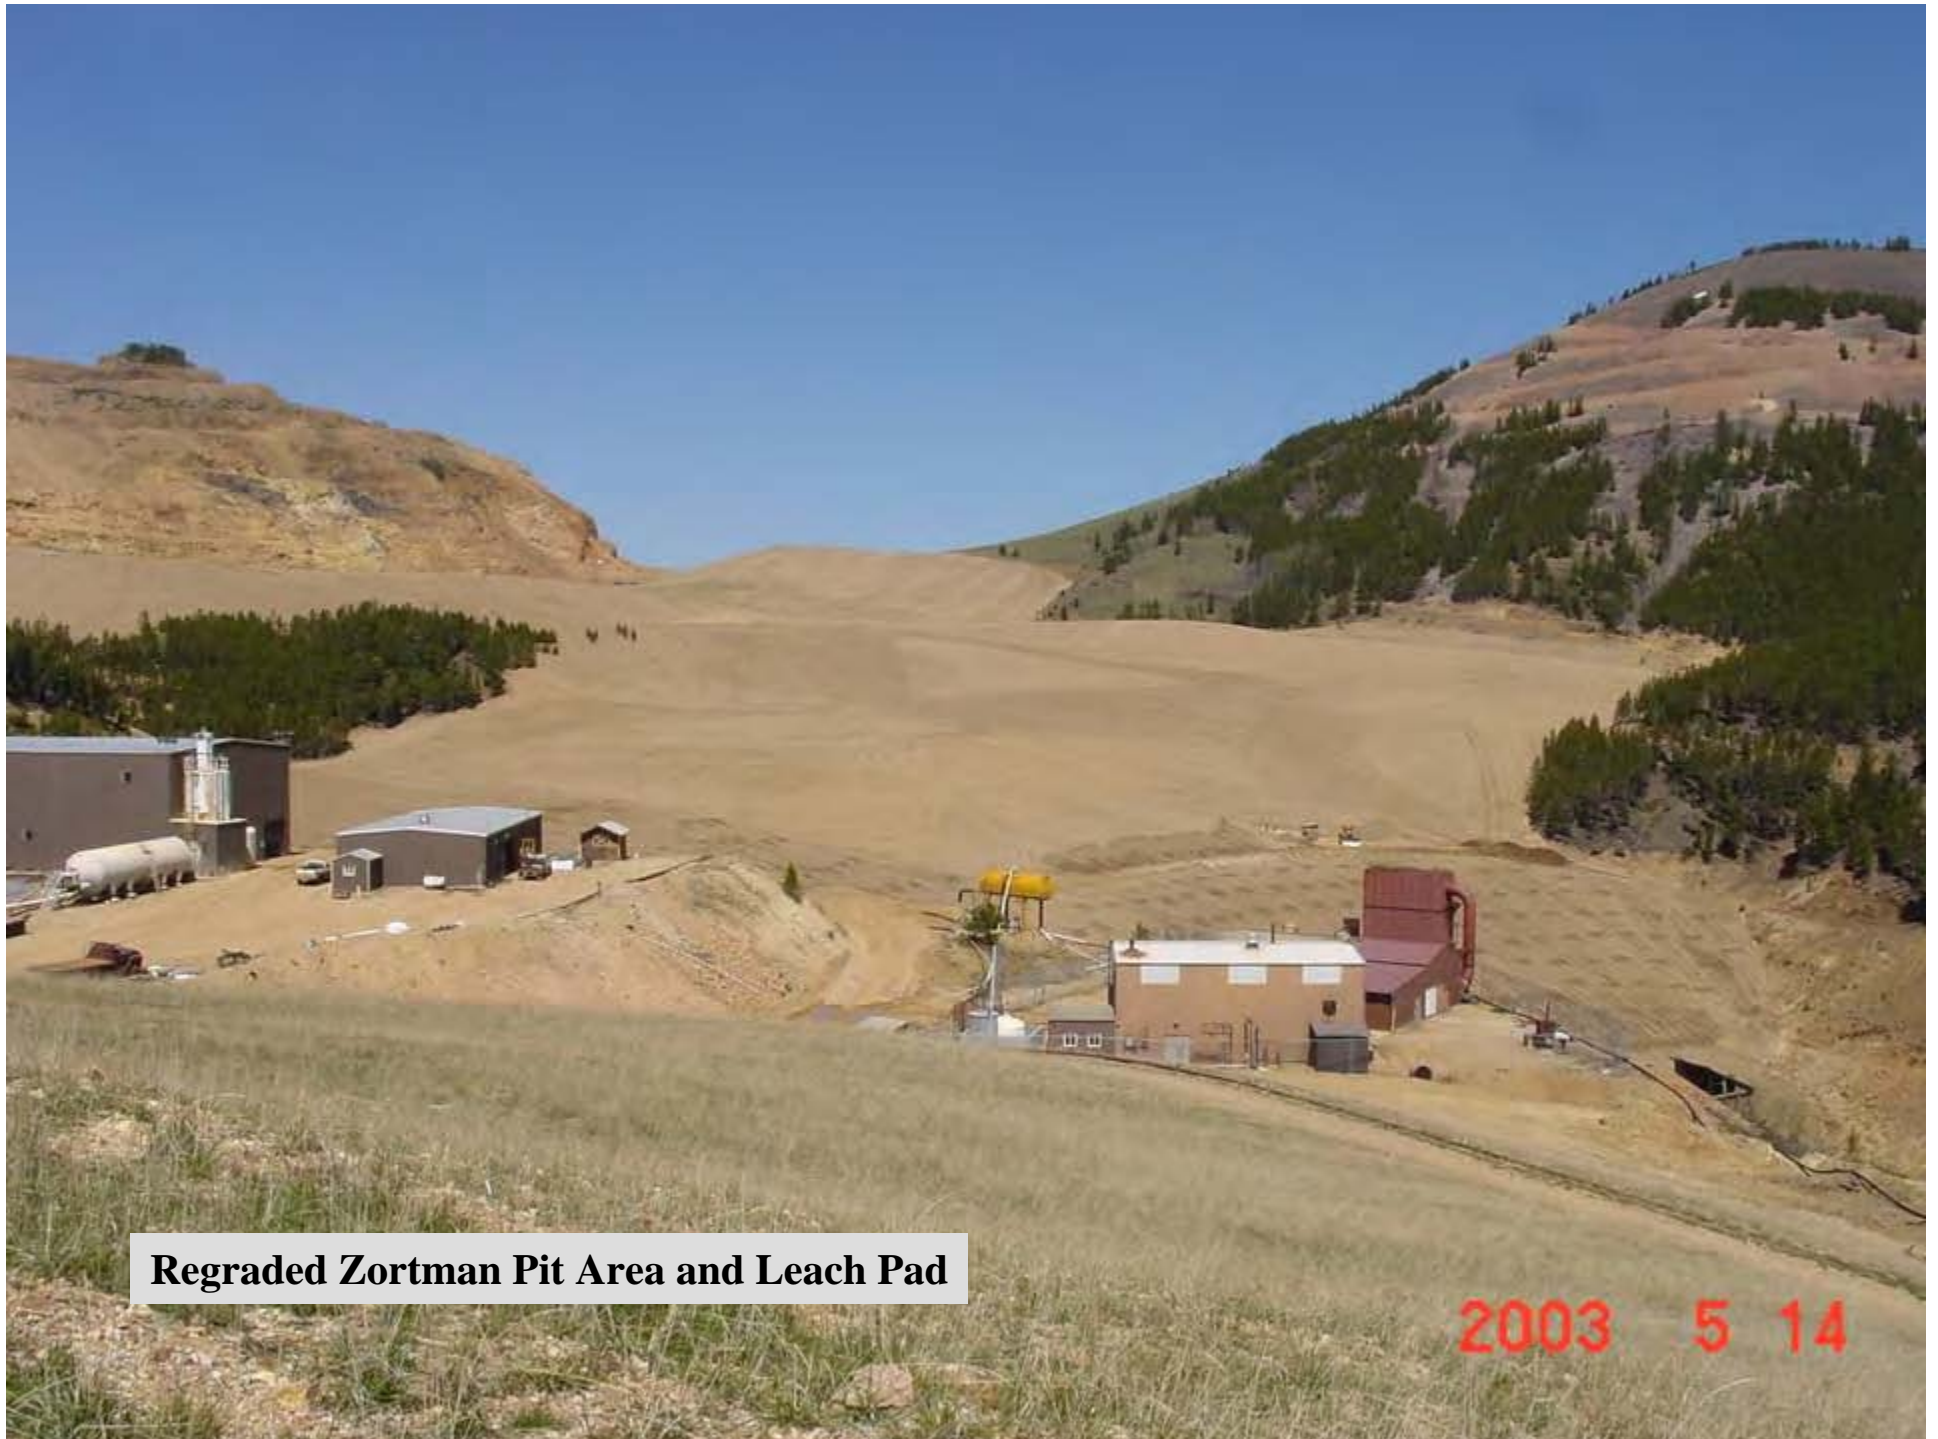
2003 5 14

Regraded Zortman Pit Area and Leach Pad

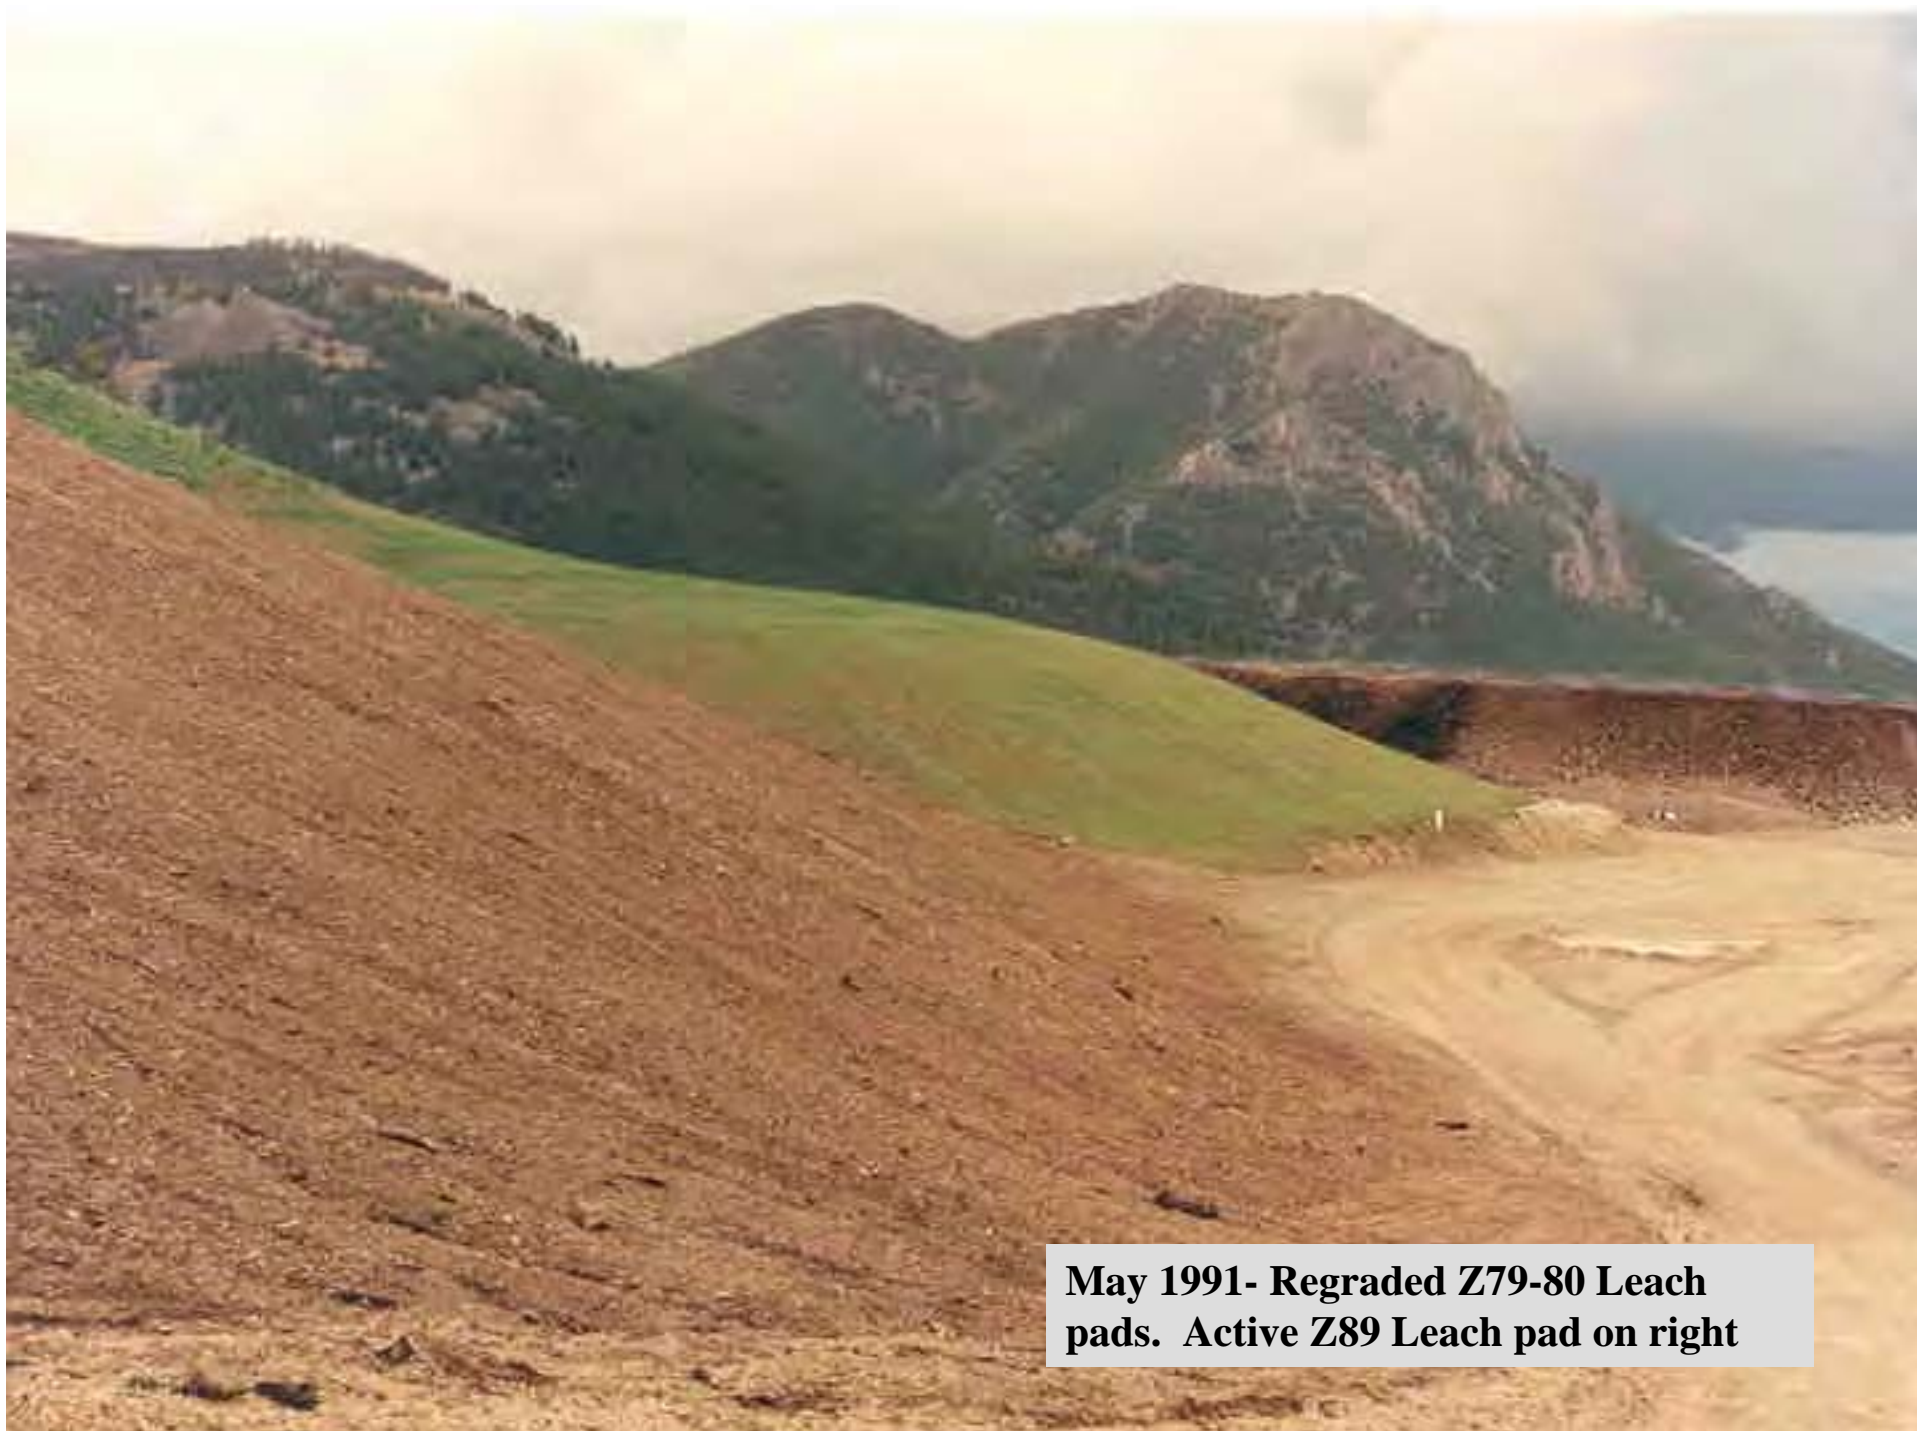
May 1991- Regraded Z79-80 Leach pads. Active Z89 Leach pad on right

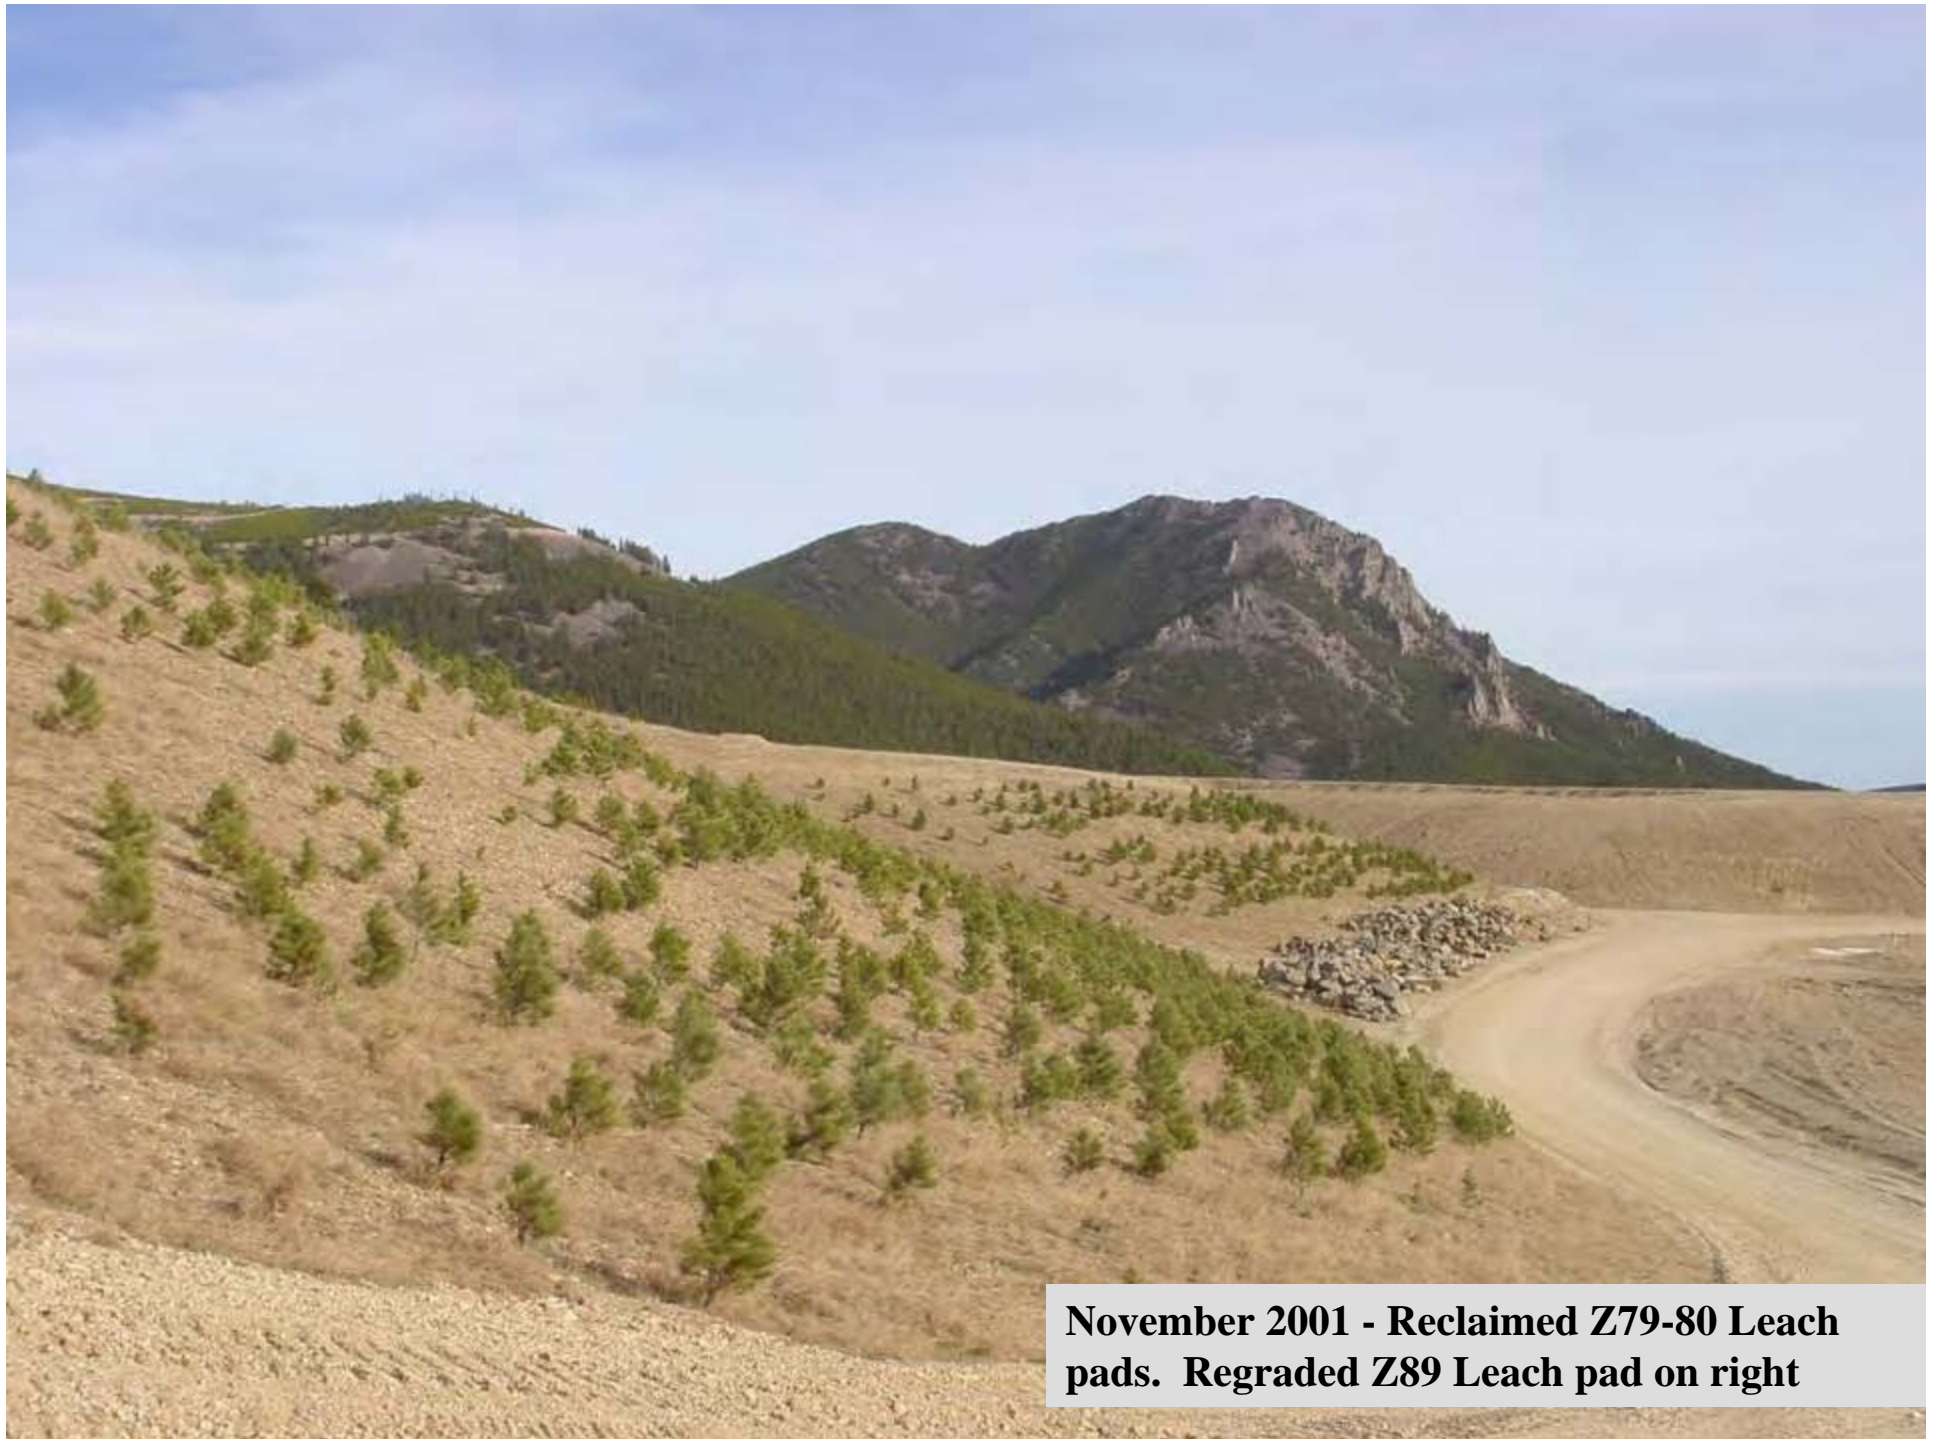
November 2001 - Reclaimed Z79-80 Leach pads. Regraded Z89 Leach pad on right

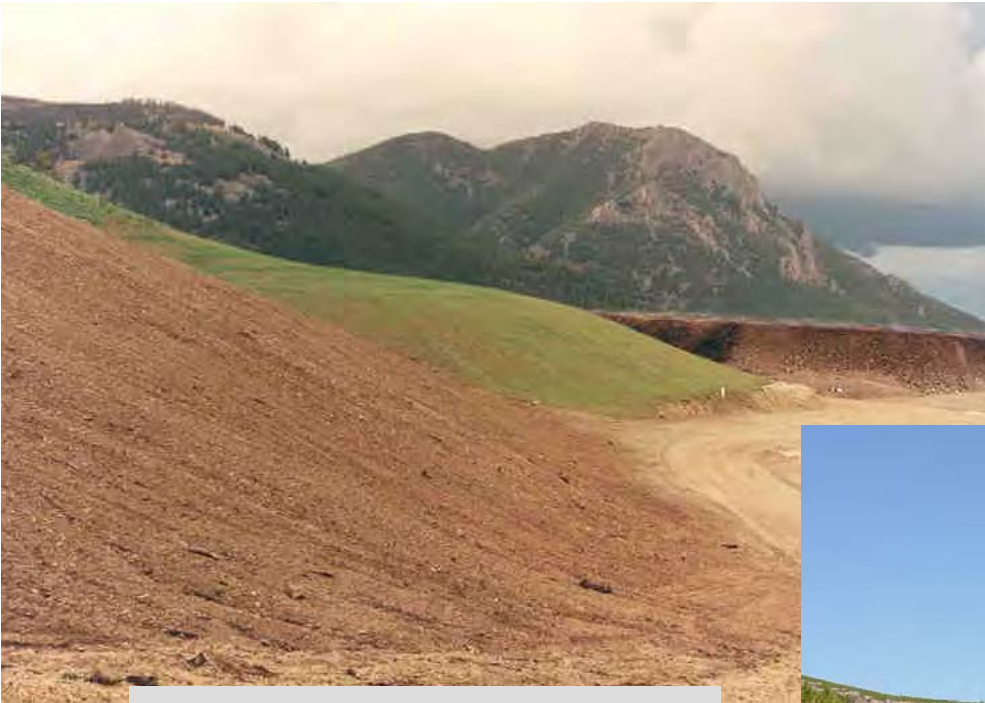
**May 1991. Z79-80 Leach pads.
Active Z89 leach pad to the right**

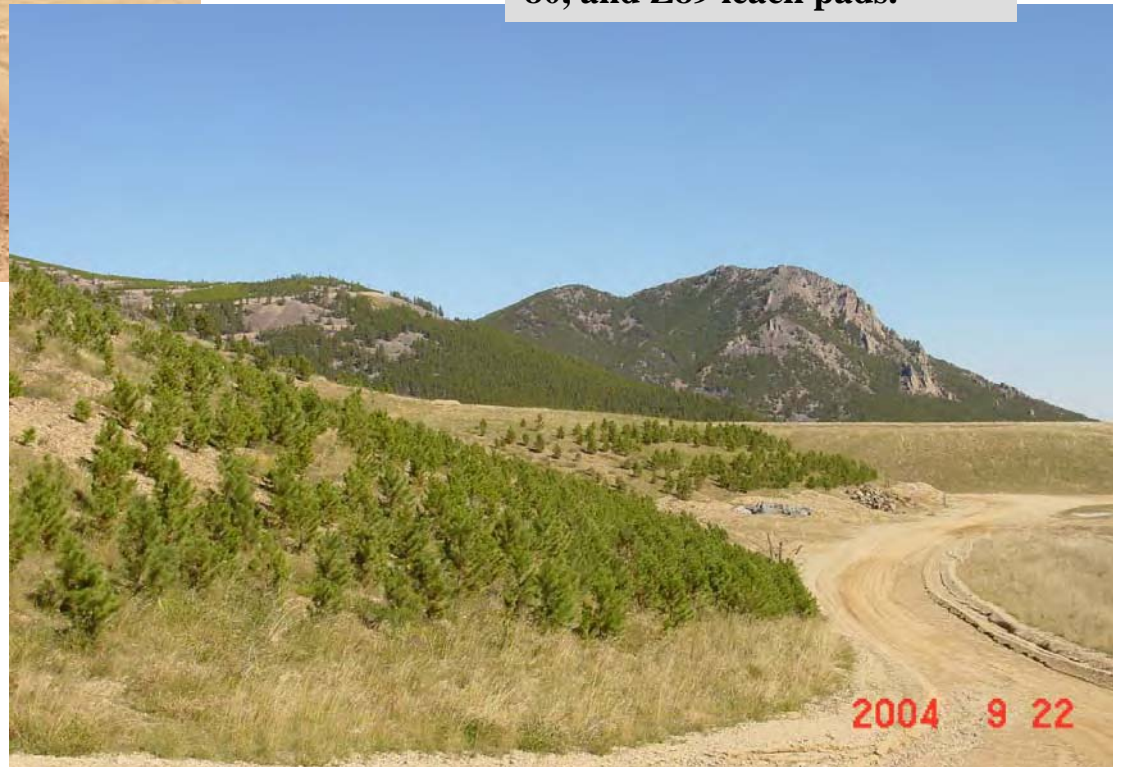
Sept. 2004 - Reclaimed Z79-80, and Z89 leach pads.

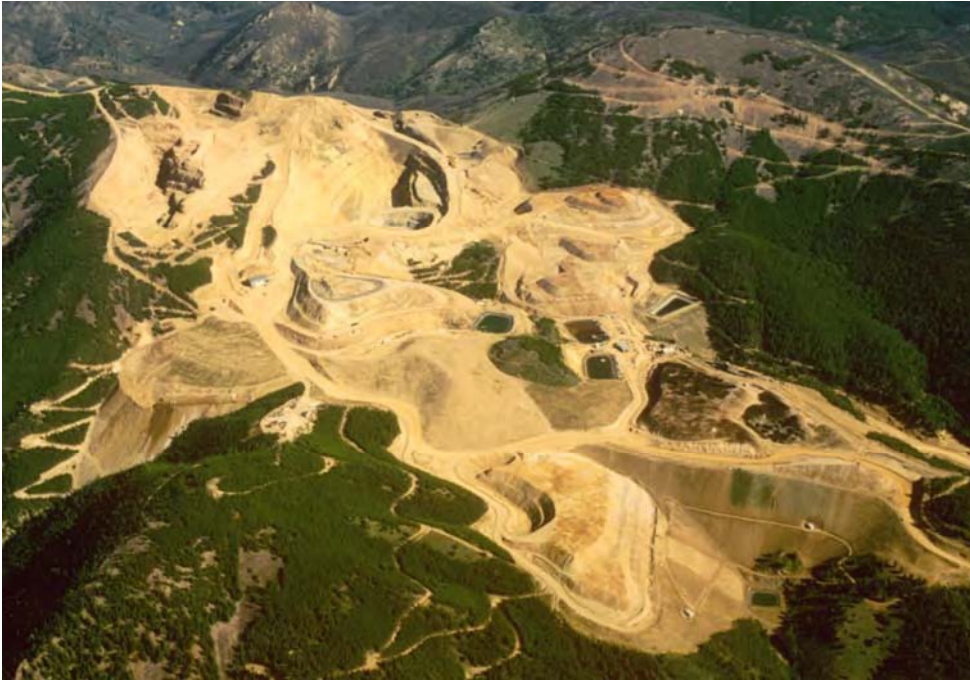
June 1993 – At Full Buildout

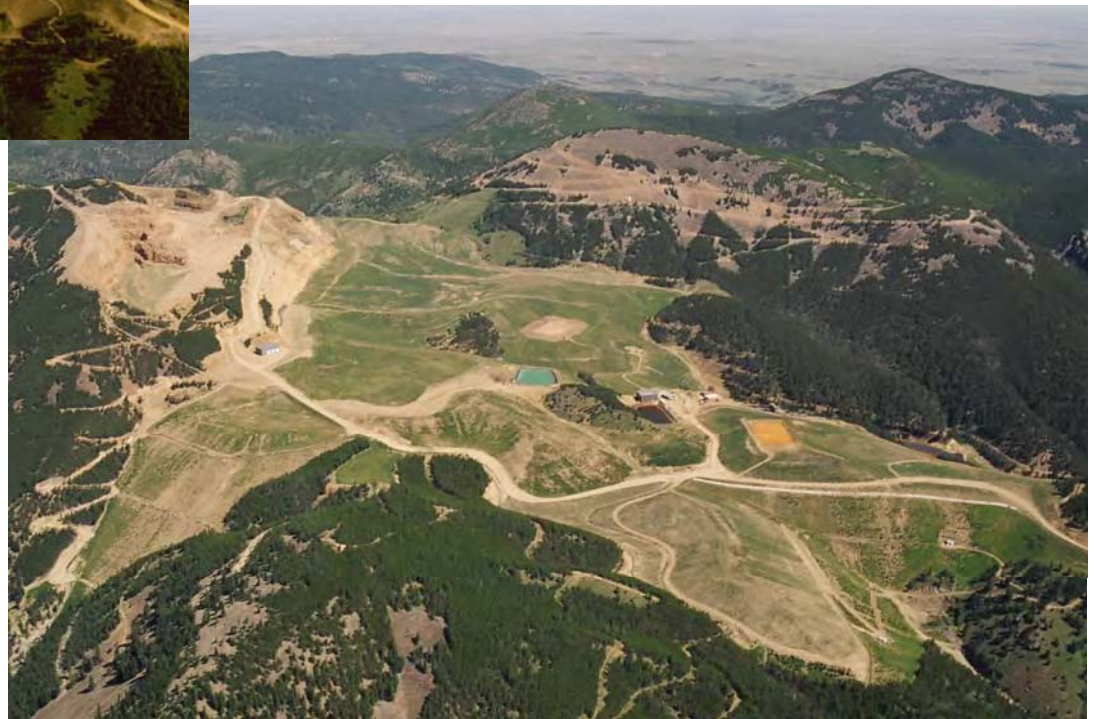
July 2005 – Reclamation Complete
